United States Nuclear Regulatory Commission  
Document Control Desk  
Washington, D. C. 20555-0001Subject: Response to Questions Regarding the 2002 Steam Generator Tube Inspections  
(TAC No. MB9541)

RESPONSE TO QUESTIONS ON LICENSEE'S RESPONSES  
TO REQUEST FOR ADDITIONAL INFORMATION  
DAVIS-BESSE NUCLEAR POWER STATION  
2002 STEAM GENERATOR INSPECTION (TAC No. MB9541)

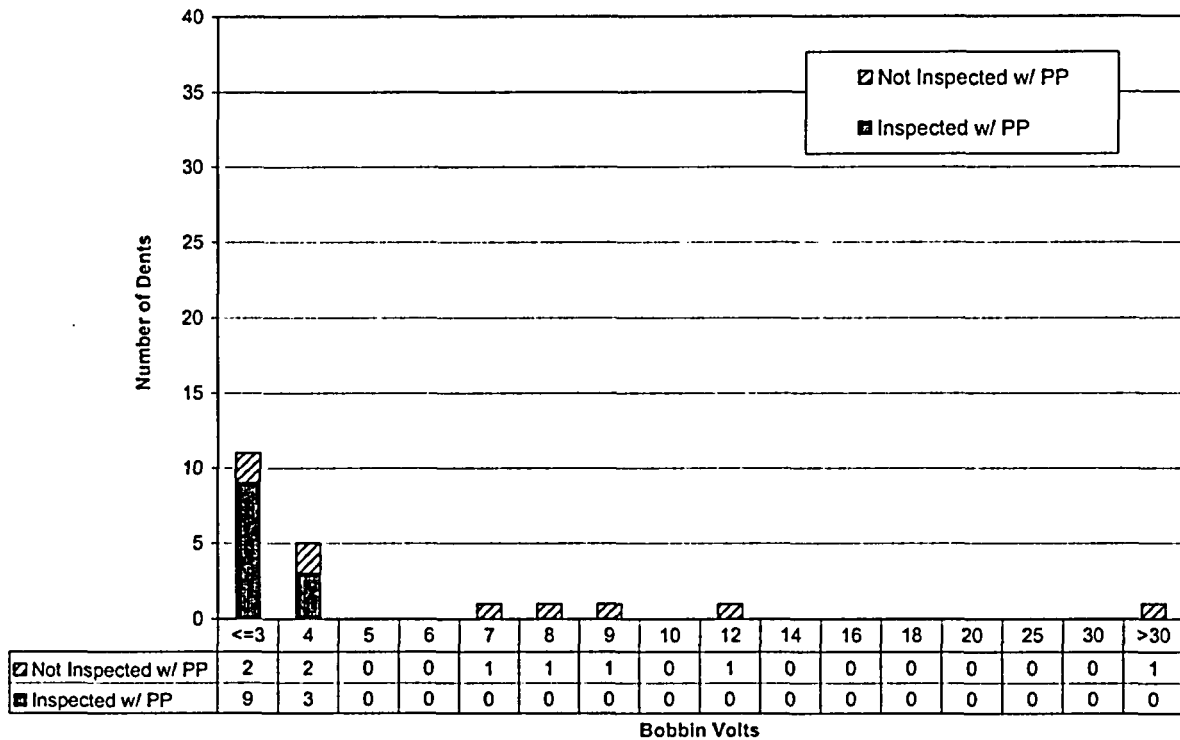
**Voltage Distribution for Dents Between LTS and 14S**  
**DBNPS SG 2-A 02/02 13RFO**

As previously stated, 100% of the dents located at or above the 14<sup>th</sup> TSP were inspected during 13RFO, and for dents below the 14<sup>th</sup> TSP, the DBNPS completed a 100% sample in three cycles with no indications of degradation present in any of the inspections. As requested, the figures provided below indicate the inspected versus uninspected population of dents in the region below the 14<sup>th</sup> TSP (not including dents at or in the LTS region) during the 13RFO inspection. Note that the 30 volt dent in A-61-109 was inspected in 12RFO with a +Point probe and no degradation was detected (dent present in history). Sampling in both OTSGs at the LTS sludge and dented region is accomplished under a separate inspection program.

no expansion of the dent inspection scope was performed at 13RFO and the tube integrity analyses did not include any adjustments for the uninspected dent population. As demonstrated by the Figures, the inspected population provided a sufficient interrogation of dents such that if degradation existed in this region, the sample would have been sufficient to provide a high probability of detecting active degradation in the sample. At the next scheduled inspection of the OTSGs, the DBNPS is planning on inspecting 100% of all dents in all areas of the OTSGs, as well as preventive plugging of significant dents in the region at or above the 14<sup>th</sup> TSP in the periphery (damaged from auxiliary feedwater (AFW) header issues), where existing conditions (temperature, flow, loads) could accelerate tube degradation at the dented area.
